**Flood Control Project Maintenance  
Levee Inspections**  
**LMA District Cover Sheet**  
**Spring 2017 Levee Inspection Results**

**Sacramento Maintenance Yard Maintenance Area 0009**

Waterway			Bank	Unit Miles
Unit No. 01 Sacramento River			Left	19.35
	Spring (March - May)	Summer (June - August)	(September - November) Fall	Winter (December - February)
Unit Maintenance Rating (Fall Only)				
Date of Inspection	4/25/2017 - 4/26/2017			
DWR Inspector	Zach Jojola			
Accompanied By	Dave Williams Sacramento Maintenance Yard

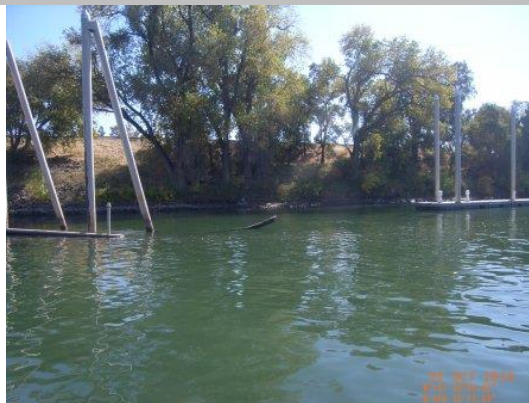
Photo 1 of 1 : SP\_2017\_MA0009\_201\_1\_20170320\_00001.jpg

LM Start	0.39	Rating **	M	Issue No.	1
LM End	0.46	Issue Type +	Ma	Location *	WS
Category	Supplemental			GPS Latitude/Longitude	
				Start	End
Item	2015 USACE Erosion Survey, DRAFT			38.536756 °	38.536036 °
				-121.516107 °	-121.517087 °
DWR ID	DWR_MA0009_01_s_2016_1				
Comment Code					
Inspector Comment					
1997 - Large cottonwoods on slope. 2003 - Some minor sloughing. 2004 - New sediment deposition on the downstream end. 2007 - New dock was installed without notification to USACE and halted the planned repair due to ROW issues. 2015: Minor new erosion at toe. [2015 Site ID: SAC_55-5_L]

USACE 2013 Photo #1

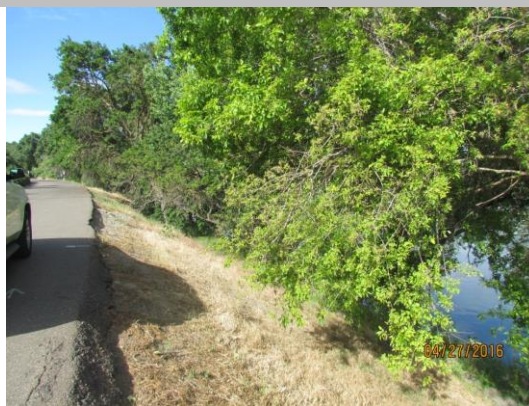
Photo 1 of 1 : SP\_2017\_MA0009\_201\_281\_20170320\_00203.jpg

View of the trees on the waterward side of the levee looking downstream. Spring 2016.

LM Start	0.40	Rating **	M	Issue No.	281
LM End	0.40	Issue Type +	Ma	Location *	WS
Category	Earthen Levee			GPS Latitude/Longitude	
				Start	End
Item	Trim / Thin Trees			38.536556 °	38.536556 °
				-121.515990 °	-121.515990 °
DWR ID	DWR_MA0009_01_f _ 2015_281				
Comment Code					
T1 : Trim trees to at least five feet above ground level.					
Inspector Comment

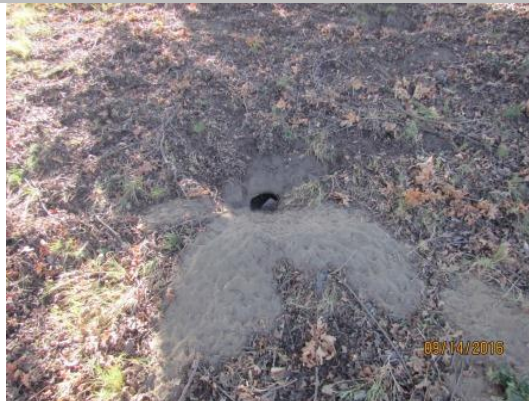
Photo 2 of 4 : SP\_2017\_MA0009\_201\_282\_20170320\_00205.jpg

LM Start	0.53	Rating **	U	Issue No.	282
LM End	0.53	Issue Type +	Ma	Location *	WS
Category	Earthen Levee			GPS Latitude/Longitude	
				Start	End
Item	Animal Control			38.534930 °	38.534930 °
				-121.517314 °	-121.517314 °
DWR ID	DWR_MA0009_01_f_2015_282				
Comment Code					
A1 : Exterminate rodents and backfill and compact or grout burrows.					
Inspector Comment					
More animal burrows were found during Fall 2016 inspection.

View of the rodent holes on waterside of the levee.

LM Start	0.53	Rating **	U	Issue No.	282 (cont)	
LM End	0.53	Issue Type +	Ma	Location *	WS	
Category	Earthen Levee			GPS Latitude/Longitude		
				Start		End
Item	Animal Control			38.534930 °		38.534930 °
				-121.517314 °		-121.517314 °
DWR ID	DWR_MA0009_01_f_2015_282					
Comment Code						
A1 : Exterminate rodents and backfill and compact or grout burrows.						
Inspector Comment						
More animal burrows were found during Fall 2016 inspection.

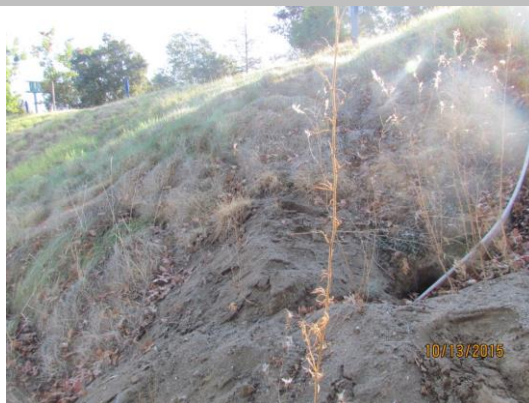
Photo 3 of 4 : SP\_2017\_MA0009\_201\_282\_20170320\_00206.jpg

View of the rodent hole on the waterward side of the levee. Fall 2015.

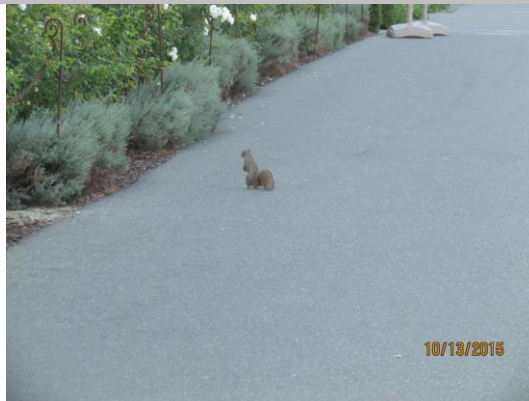
Photo 4 of 4 : SP\_2017\_MA0009\_201\_282\_20170320\_00207.jpg

Rodents are sighted near the Westin Hotel. Fall 2015.

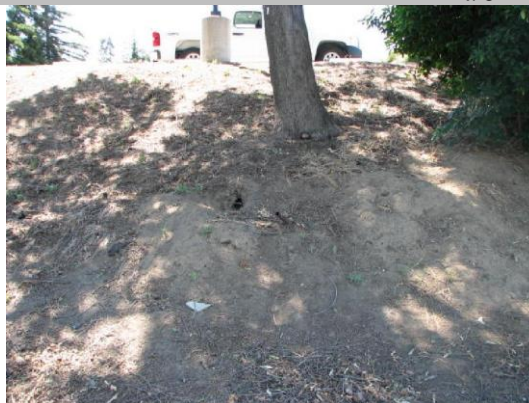
Photo 1 of 2 : UCIP\_SP\_2017\_47076\_8695.jpg

FS\_ID:47076  
DS\_ID:18890  
EP\_NO: N/A  
Repair Type: Non-Urgent  
Crossing Status: Found  
UCIP Comments: Pipe is open on WS and may need to be removed or Abandoned in place. Only WS of pipe could be seen.  
FIELD\_STRUCT\_DESC: 1-inch steel pipe through levee, 10.0 feet below crown. Purpose unknown.  
FS Date: 6/19/2012 2:51:00 PM

Pipe exiting bank just below tree at center of photo on WS slope.

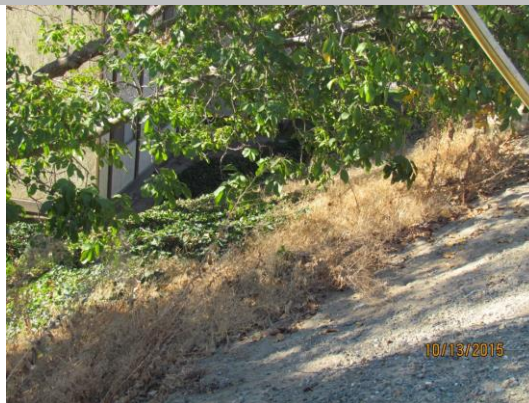
Photo 1 of 2 : SP\_2017\_MA0009\_201\_7\_20170320\_00006.jpg

LM Start	0.66	Rating **	M	Issue No.	7
LM End	0.70	Issue Type +	En	Location *	LS
Category	Earthen Levee			GPS Latitude/Longitude	
				Start	End
Item	Encroachments			38.534105 °	38.533870 °
				-121.519389 °	-121.520134 °
DWR ID	DWR_MA0009_01_s_2012_7				
Comment Code					
BU : Building					
Inspector Comment

Landscaping at the toe of the levee on the landward side of the levee.  
Fall 2015.

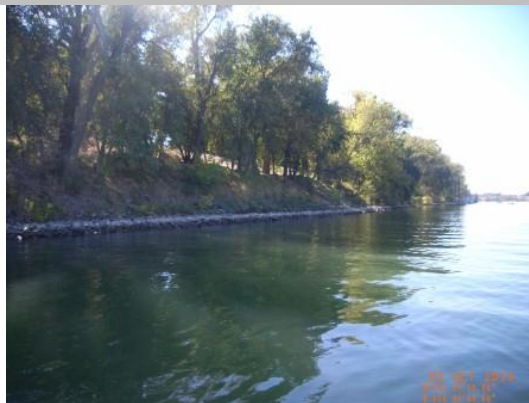
Photo 1 of 2 : SP\_2017\_MA0009\_201\_8\_20170320\_00008.jpg

LM Start	0.70	Rating **	M	Issue No.	8
LM End	0.86	Issue Type +	Ma	Location *	WS
Category	Supplemental			GPS Latitude/Longitude	
				Start	End
Item	2015 USACE Erosion Survey, DRAFT			38.534144 °	38.533143 °
				-121.520263 °	-121.523010 °
DWR ID	DWR_MA0009_01_s_2016_8				
Comment Code					
Inspector Comment					
Site previously named 55.1. 2003 - Pockets of toe erosion at low flow waterline. 2005 - Site renamed 55.2. Still have pockets of erosion but rock bench at waterline is still present. 2010 - Site extended upstream due to new erosion. 2011 - Some of the toe rock has failed. The upper levee slope seems to be slumping. 2012 - Minor new slumping. 2015: No observed changes. [2015 Site ID: SAC_55-2_L]

USACE 2013 Photo #1

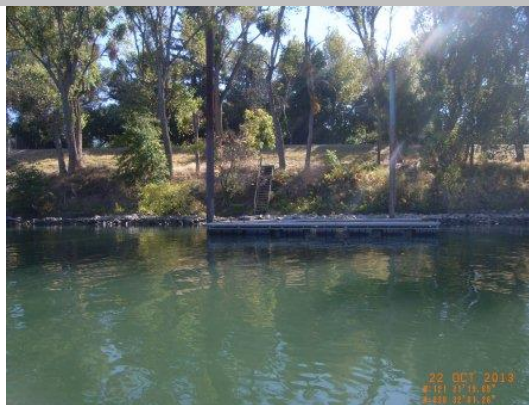
Photo 2 of 2 : SP\_2017\_MA0009\_201\_8\_20170320\_00009.jpg

USACE 2013 Photo #2

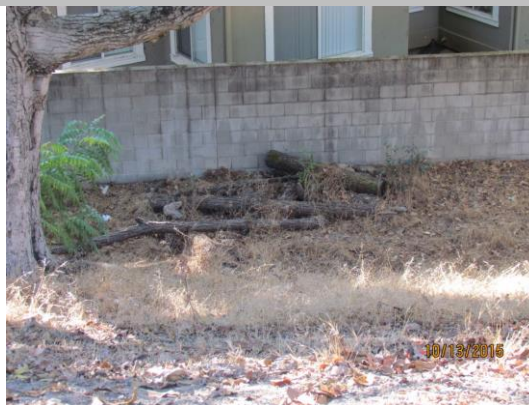
Photo 1 of 1 : SP\_2017\_MA0009\_201\_1251\_20170320\_00301.jpg

LM Start	0.72	Rating **	M	Issue No.	1251
LM End	0.72	Issue Type +	Ma	Location *	LS
Category	Earthen Levee			GPS Latitude/Longitude	
				Start	End
Item	Encroachments			38.533770 °	38.533770 °
				-121.520452 °	-121.520452 °
DWR ID	DWR_MA0009_01_s_2012_1251				
Comment Code					
TR : Tree or limb					
Inspector Comment

View of the limbs and brush at the toe of the levee on the landward side. Fall 2015.

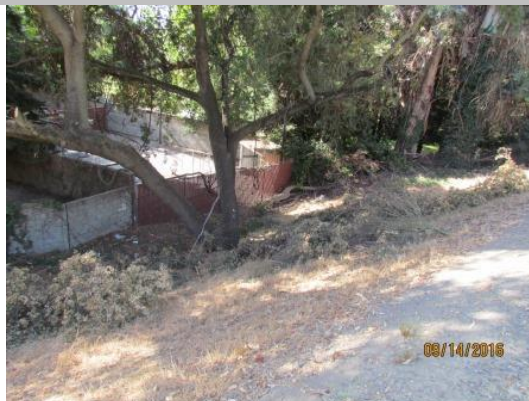
Photo 1 of 2 : SP\_2017\_MA0009\_201\_295\_20170320\_00212.jpg

LM Start	0.78	Rating **	M	Issue No.	295
LM End	0.78	Issue Type +	En	Location *	LS
Category	Earthen Levee			GPS Latitude/Longitude	
				Start	End
Item	Encroachments			38.533393 °	38.533393 °
				-121.521479 °	-121.521479 °
DWR ID	DWR_MA0009_01_s _ 2015_295				
Comment Code					
PR : Prunings					
Inspector Comment

Pruning and other trash on landward side of the levee. Fall 2016 inspection.

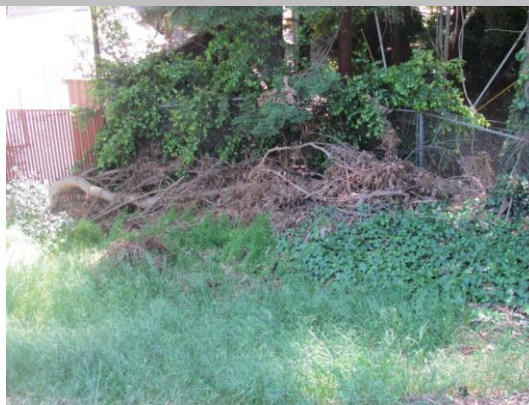
Photo 2 of 2 : SP\_2017\_MA0009\_201\_295\_20170320\_00213.jpg

View of the prunings at the toe of the landward side of the levee. Spring 2015.

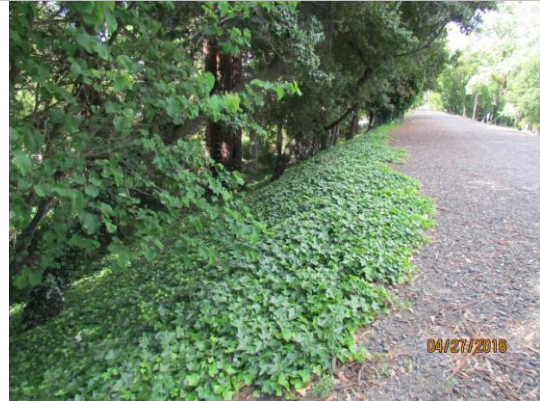
Photo 1 of 1 : SP\_2017\_MA0009\_201\_10\_20170320\_00010.jpg

LM Start	0.79	Rating **	M	Issue No.	10
LM End	0.81	Issue Type +	En	Location *	LS
Category	Earthen Levee			GPS Latitude/Longitude	
				Start	End
Item	Vegetation			38.533348 °	38.533207 °
				-121.521576 °	-121.521916 °
DWR ID	DWR_MA0009_01_f _ 2016_10				
Comment Code					
V6 : Landscaping					
Inspector Comment					
Fence and trees are permitted by Permit 12394, but groundcover is not. Groundcover obstructs visibility.

View of the vegetation on the landward side of the levee looking downstream. Spring 2016.

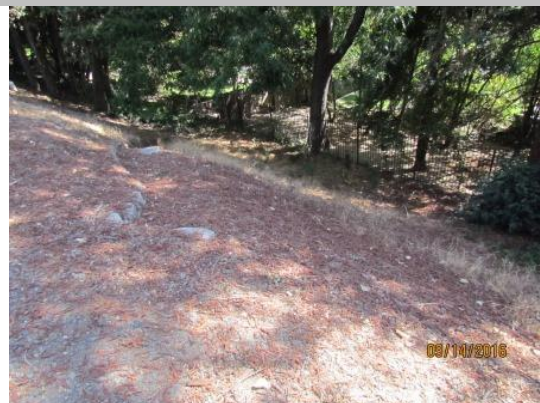
Photo 1 of 1 : SP\_2017\_MA0009\_201\_242\_20170320\_00186.jpg

LM Start	0.83	Rating **	M	Issue No.	242
LM End	0.83	Issue Type +	En	Location *	LS
Category	Earthen Levee			GPS Latitude/Longitude	
				Start	End
Item	Encroachments			38.533056 °	38.533056 °
				-121.522339 °	-121.522339 °
DWR ID	DWR_MA0009_01_f_2016_242				
Comment Code					
RA : Ramp					
Inspector Comment

Old ramp on landside slope of the levee. Fall 2016 inspection.

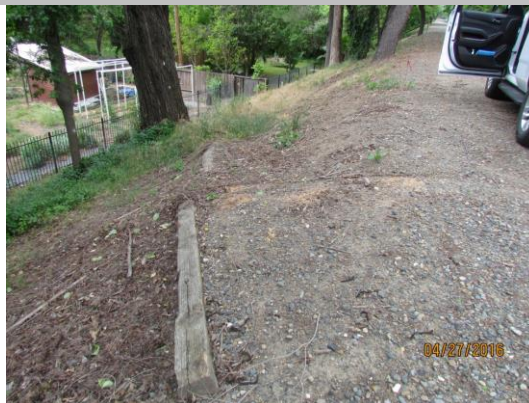
Photo 1 of 1 : SP\_2017\_MA0009\_201\_13\_20170320\_00015.jpg

LM Start	0.85	Rating **	M	Issue No.	13
LM End	0.85	Issue Type +	En	Location *	LS
Category	Earthen Levee			GPS Latitude/Longitude	
				Start	End
Item	Encroachments			38.532945 °	38.532920 °
				-121.522570 °	-121.522648 °
DWR ID	DWR_MA0009_01_s_2012_13				
Comment Code					
RA : Ramp					
Inspector Comment

View of the ramp that cuts into the levee slope on the landward side looking downstream. Spring 2016.

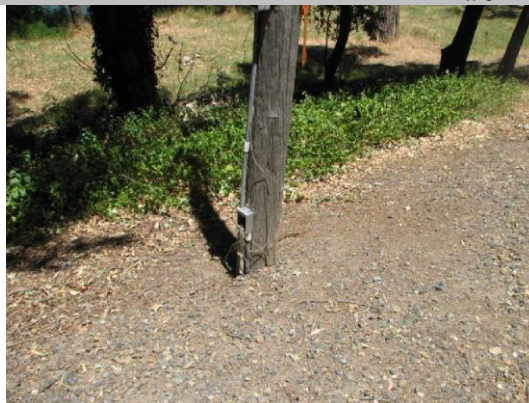
Photo 1 of 2 : UCIP\_SP\_2017\_41534\_6104.jpg

FS\_ID:41534  
DS\_ID:17407  
EP\_NO: N/A  
Repair Type: Non-Urgent  
Crossing Status: Found  
UCIP Comments: Appears abandoned.  
FIELD\_STRUCT\_DESC: 1.5-inch Electrical conduit through the levee.  
Pole on waterward slope.  
FS Date: 6/19/2012 7:58:00 AM

Electrical conduit at bottom of pole on water side.

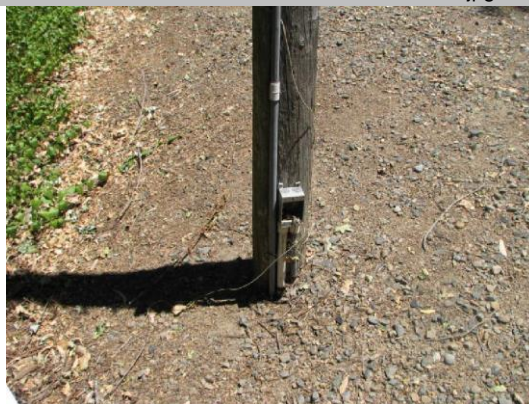
Photo 2 of 2 : UCIP\_SP\_2017\_41534\_6103.jpg

Electrical conduit at bottom of pole on water side.

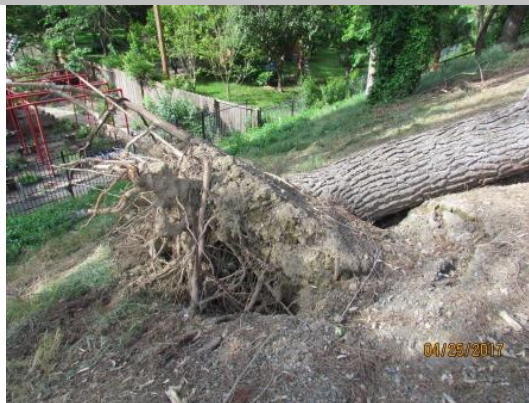
Photo 1 of 1 : SP\_2017\_MA0009\_201\_236\_20170426\_00498.jpg

LM Start	0.86	Rating **	M	Issue No.	236
LM End	0.86	Issue Type +	Ma	Location *	LS
Category	Earthen Levee			GPS Latitude/Longitude	
				Start	End
Item	Slope Stability			38.532902 °	38.532902 °
				-121.522707 °	-121.522707 °
DWR ID	DWR_MA0009_01_s_2017_236				
Comment Code					
S1 : Repair slope instability.					
Inspector Comment					
Fallen tree has exposed root system and created a void within the levee prism.

View of fallen tree on landside slope. Spring 2017.

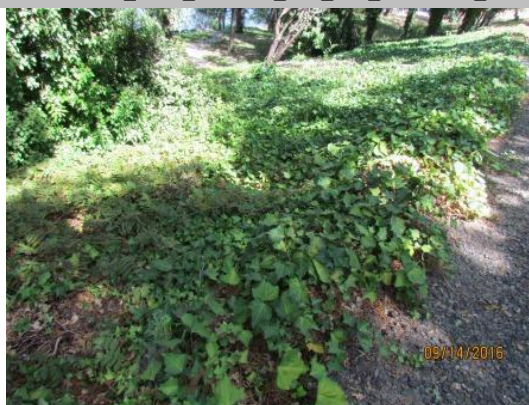
Photo 1 of 2 : SP\_2017\_MA0009\_201\_292\_20170320\_00209.jpg

LM Start	0.87	Rating **	U	Issue No.	292
LM End	0.92	Issue Type +	En	Location *	WS
Category	Earthen Levee			GPS Latitude/Longitude	
				Start	End
Item	Vegetation			38.532847 °	38.532504 °
				-121.522872 °	-121.523770 °
DWR ID	DWR_MA0009_01_f_2016_292				
Comment Code					
V6 : Landscaping					
Inspector Comment					
Permit 6292-A covers the fence, sprinkler system, a light pole, and wooden steps. Groundcover is obstructing visibility.

Landscaping on waterward slope. Fall 2016 inspection.

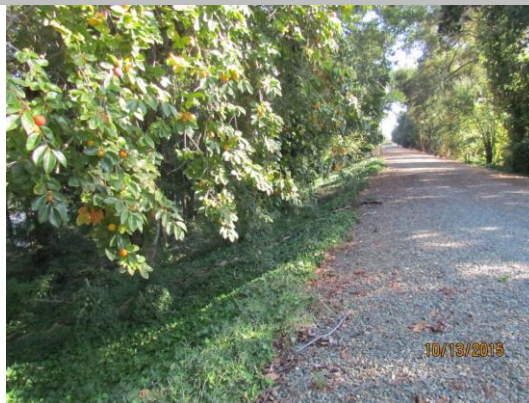
Photo 2 of 2 : SP\_2017\_MA0009\_201\_292\_20170320\_00210.jpg

View of the landscaping on the waterward side of the levee looking upstream. Fall 2015.

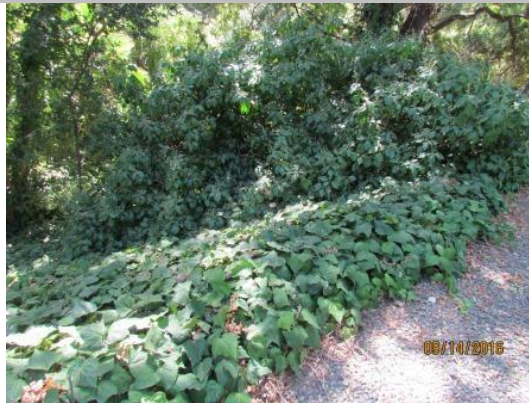
Photo 1 of 2 : SP\_2017\_MA0009\_201\_15\_20170320\_00016.jpg

LM Start	0.88	Rating **	U	Issue No.	15
LM End	0.90	Issue Type +	En	Location *	LS
Category	Earthen Levee			GPS Latitude/Longitude	
				Start	End
Item	Vegetation			38.532730 °	38.532628 °
				-121.523129 °	-121.523406 °
DWR ID	DWR_MA0009_01_s_2012_15				
Comment Code					
V6 : Landscaping					
Inspector Comment					
Permit 16347 covers the English ivy groundcover and five ornamental trees on the landside. Trees are obstructing view and need to be trimmed.

Groundcover on landside slope. Fall 2016 inspection.

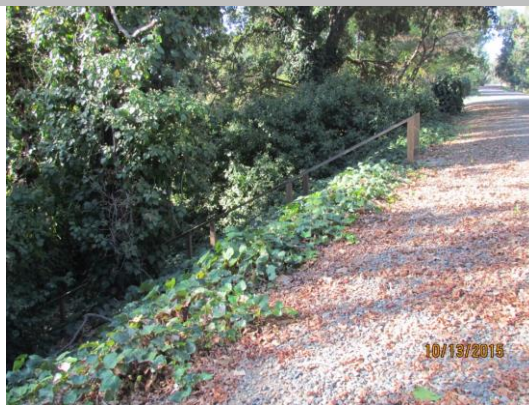
Photo 2 of 2 : SP\_2017\_MA0009\_201\_15\_20170320\_00017.jpg

View of the groundcover and trees on the landward side of the levee looking downstream. Fall 2015.

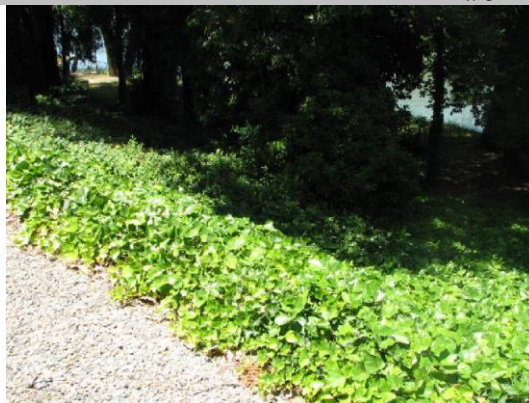
Photo 1 of 2 : UCIP\_SP\_2017\_40523\_6122.jpg

LM Start	0.90	Rating **	M	Issue No.	1773
LM End	0.90	Issue Type +	En	Location *	LS
Category	Supplemental			GPS Latitude/Longitude	
				Start	End
Item	DWR UCIP Field Study			38.532640 °	38.532640 °
				-121.523370 °	-121.523370 °
DWR ID					
Comment Code					
Inspector Comment					
FS_ID:40523					
DS_ID:17727					
EP_NO: 4809					
Repair Type: Non-Urgent					
Crossing Status: Indicator Found					
UCIP Comments: Could not locate service box due to excessive vegetation (see Pics) Possible electrical conduit crossing at this same location.					
FIELD_STRUCT_DESC: 3/4-inch domestic water supply with valve on land side.					
FS Date: 6/19/2012 2:00:00 PM

Excessive vegetation on waterside.

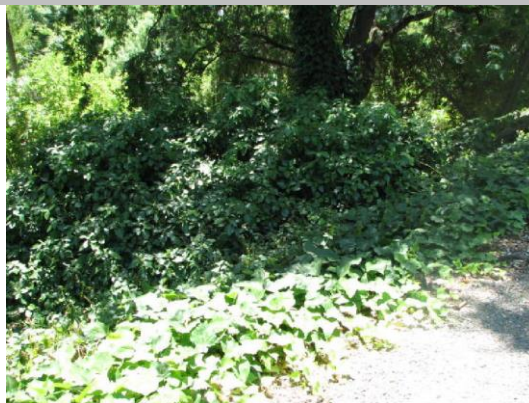
Photo 2 of 2 : UCIP\_SP\_2017\_40523\_6121.jpg

Excessive vegetation on landside.

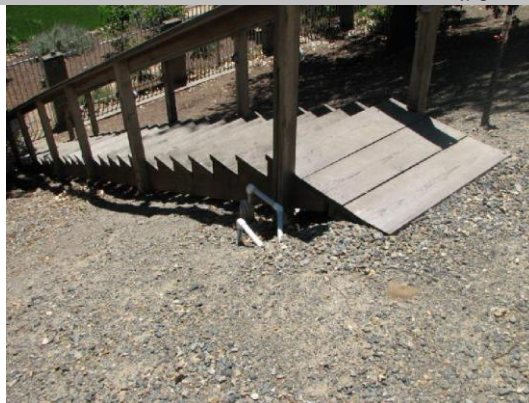
Photo 1 of 2 : UCIP\_SP\_2017\_5842\_8908.jpg

LM Start	0.94	Rating **	M	Issue No.	1774
LM End	0.94	Issue Type +	En	Location *	LS
Category	Supplemental			GPS Latitude/Longitude	
				Start	End
Item	DWR UCIP Field Study			38.532380 °	38.532380 °
				-121.524080 °	-121.524080 °
DWR ID					
Comment Code					
Inspector Comment					
FS_ID:5842 DS_ID:18896 EP_NO: N/A Repair Type: Non-Urgent Crossing Status: Found UCIP Comments: No permit identified for this crossing. Pipe located 1-foot upstream of stairs on LS slope. FIELD_STRUCT_DESC: 0.75-inch electric line through the levee, 1.0 foot below the crown. FS Date: 6/19/2012 9:19:25 AM

Electrical conduit on LS slope just upstream of stairs.

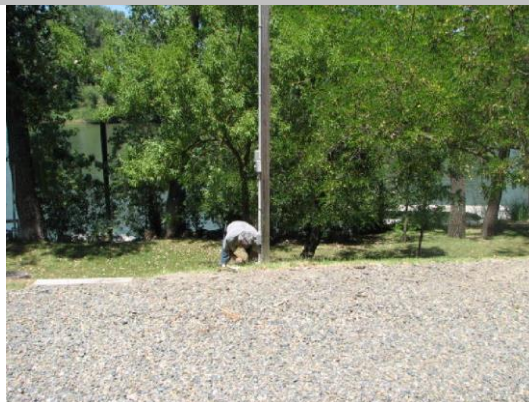
Photo 2 of 2 : UCIP\_SP\_2017\_5842\_8907.jpg

Light on Post WS slope at crossing.

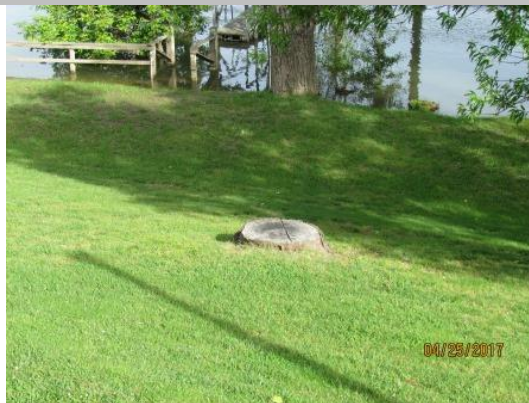
Photo 1 of 1 : SP\_2017\_MA0009\_201\_237\_20170426\_00499.jpg

LM Start	0.94	Rating **	N	Issue No.	237
LM End	0.94	Issue Type +	Ma	Location *	WS
Category	Earthen Levee			GPS Latitude/Longitude	
				Start	End
Item	Trim / Thin Trees			38.532357 °	38.532357 °
				-121.524112 °	-121.524112 °
DWR ID	DWR_MA0009_01_s_2017_237				
Comment Code					
T5 : Tree stumps.					
Inspector Comment

View of stump on waterside slope. Spring 2017.

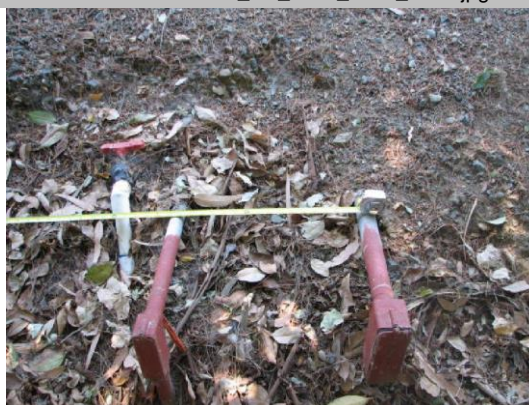
Photo 1 of 3 : UCIP\_SP\_2017\_5843\_8911.jpg

LM Start	0.97	Rating **	M	Issue No.	1775
LM End	0.97	Issue Type +	En	Location *	WS
Category	Supplemental			GPS Latitude/Longitude	
				Start	End
Item	DWR UCIP Field Study			38.532160 °	38.532160 °
				-121.524660 °	-121.524660 °
DWR ID					
Comment Code					
Inspector Comment					
FS_ID:5843 DS_ID:18898 EP_NO: N/A Repair Type: Non-Urgent Crossing Status: Found UCIP Comments: No permit identified for this crossing. FIELD_STRUCT_DESC: 1.5-inch PVC electric line through the levee, 1.5 feet below the crown. Light on pole next to irrigation box on waterside shoulder. FS Date: 6/19/2012 9:24:40 AM

Pipes on LS slope.

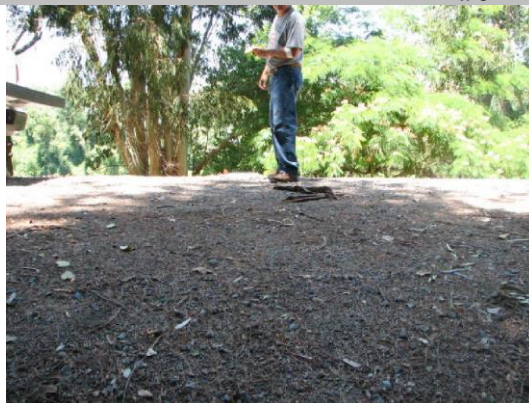
Photo 2 of 3 : UCIP\_SP\_2017\_5843\_8910.jpg

LM Start	0.97	Rating **	M	Issue No.	1775 (cont)
LM End	0.97	Issue Type +	En	Location *	WS
Category	Supplemental			GPS Latitude/Longitude	
				Start	End
Item	DWR UCIP Field Study			38.532160 °	38.532160 °
				-121.524660 °	-121.524660 °
DWR ID					
Comment Code					
Inspector Comment					
FS_ID:5843 DS_ID:18898 EP_NO: N/A Repair Type: Non-Urgent Crossing Status: Found UCIP Comments: No permit identified for this crossing. FIELD_STRUCT_DESC: 1.5-inch PVC electric line through the levee, 1.5 feet below the crown. Light on pole next to irrigation box on waterside shoulder. FS Date: 6/19/2012 9:24:40 AM

View accross slope towards WS.

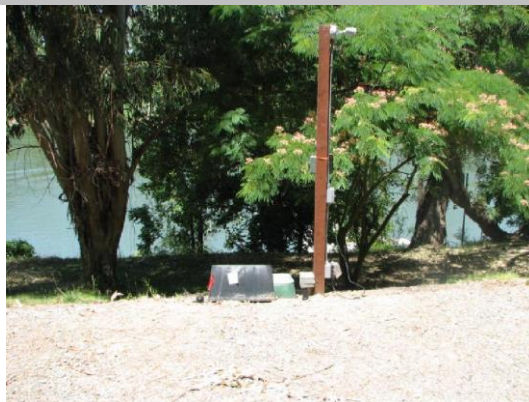
Photo 3 of 3 : UCIP\_SP\_2017\_5843\_8909.jpg

Light on Pole WS slope.

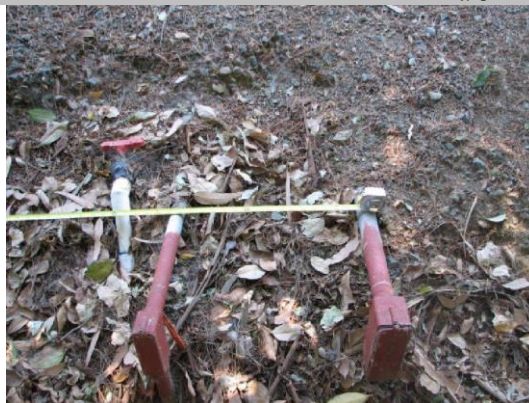
Photo 1 of 3 : UCIP\_SP\_2017\_5844\_8914.jpg

LM Start	0.98	Rating **	M	Issue No.	1776
LM End	0.98	Issue Type +	En	Location *	WS
Category	Supplemental			GPS Latitude/Longitude	
				Start	End
Item	DWR UCIP Field Study			38.532150 °	38.532150 °
				-121.524660 °	-121.524660 °
DWR ID					
Comment Code					
Inspector Comment					
FS_ID:5844					
DS_ID:18897					
EP_NO: N/A					
Repair Type: Non-Urgent					
Crossing Status: Found					
UCIP Comments: No permit identified for this crossing.					
FIELD_STRUCT_DESC: 1.0-inch PVC electric line through the levee, 1.5 feet below the crown. Light on pole next to irrigation box on waterside shoulder.					
FS Date: 6/19/2012 9:30:37 AM

Pipes visible on LS slope.

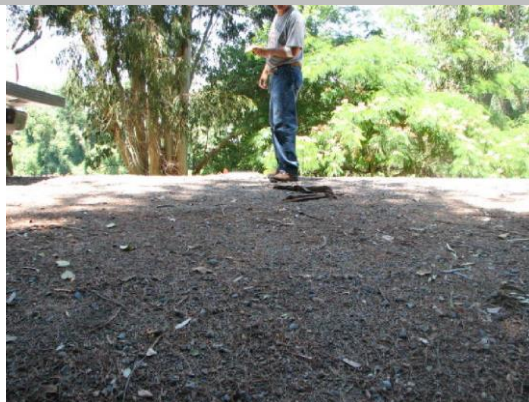
Photo 2 of 3 : UCIP\_SP\_2017\_5844\_8913.jpg

View accross levee towards WS from LS slope.

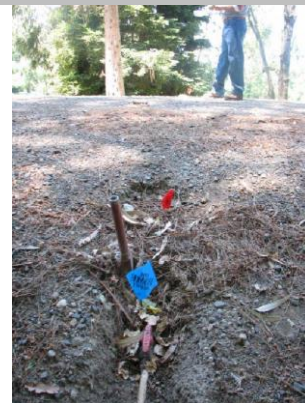
Photo 1 of 1 : UCIP\_SP\_2017\_5846\_8917.jpg

LM Start	0.99	Rating **	M	Issue No.	1778
LM End	0.99	Issue Type +	En	Location *	WS
Category	Supplemental			GPS Latitude/Longitude	
				Start	End
Item	DWR UCIP Field Study			38.532070 °	38.532070 °
				-121.524950 °	-121.524950 °
DWR ID					
Comment Code					
Inspector Comment					
FS_ID:5846 DS_ID:18900 EP_NO: N/A Repair Type: Non-Urgent Crossing Status: Found UCIP Comments: No permit identified for this crossing. FIELD_STRUCT_DESC: 1.0-inch PVC water line through the levee, 1.5 feet below the crown. Shutoff valve on landside shoulder. FS Date: 6/19/2012 9:36:43 AM

View of pipe and valve on LS shoulder looking towards WS slope.

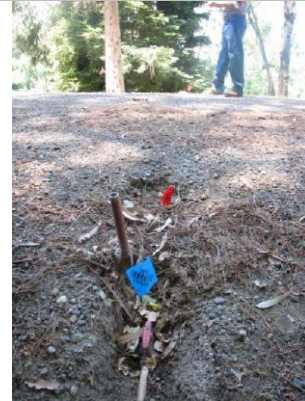
Photo 1 of 1 : UCIP\_SP\_2017\_5847\_8918.jpg

LM Start	0.99	Rating **	M	Issue No.	1779
LM End	0.99	Issue Type +	En	Location *	WS
Category	Supplemental			GPS Latitude/Longitude	
				Start	End
Item	DWR UCIP Field Study			38.532050 °	38.532050 °
				-121.524940 °	-121.524940 °
DWR ID					
Comment Code					
Inspector Comment					
FS_ID:5847 DS_ID:18901 EP_NO: N/A Repair Type: Non-Urgent Crossing Status: Found UCIP Comments: No permit identified for this crossing. FIELD_STRUCT_DESC: 1.0-inch PVC electric line through the levee, 1.5 feet below the crown. Shutoff valve on landside shoulder. FS Date: 6/19/2012 9:39:42 AM

Pipes visible on LS shoulder/slope looking towards WS.

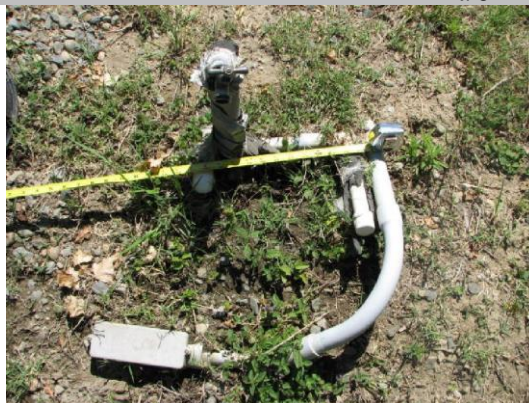
Photo 2 of 3 : UCIP\_SP\_2017\_5848\_8920.jpg

LM Start	1.01	Rating **	M	Issue No.	1780 (cont)
LM End	1.01	Issue Type +	En	Location *	WS
Category	Supplemental			GPS Latitude/Longitude	
				Start	End
Item	DWR UCIP Field Study			38.531970°	38.531970°
				-121.525210°	-121.525210°
DWR ID					
Comment Code					
Inspector Comment					
FS_ID:5848					
DS_ID:18903					
EP_NO: N/A					
Repair Type: Non-Urgent					
Crossing Status: Found					
UCIP Comments: No permit identified for this crossing.					
FIELD_STRUCT_DESC: 0.75-inch PVC water line through the levee,					
1.5 feet below the crown. Hose-bib and electric box visible on WS					
shoulder. Pipe visible on downstream side of landside shoulder stairs.					
Permit No. 6293, 1969.					
FS Date: 6/19/2012 9:42:01 AM

Closeup of hose bib.

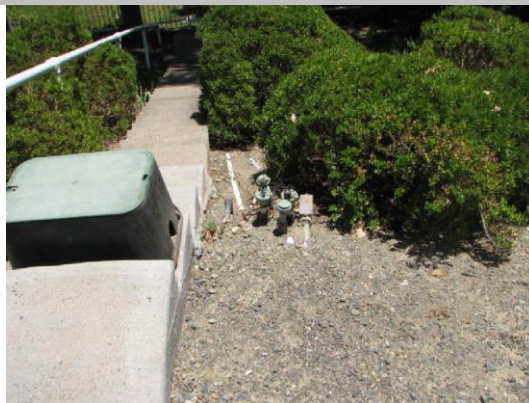
Photo 3 of 3 : UCIP\_SP\_2017\_5848\_8919.jpg

Pipes on LS slope 1-foot downstream from concrete stairs.

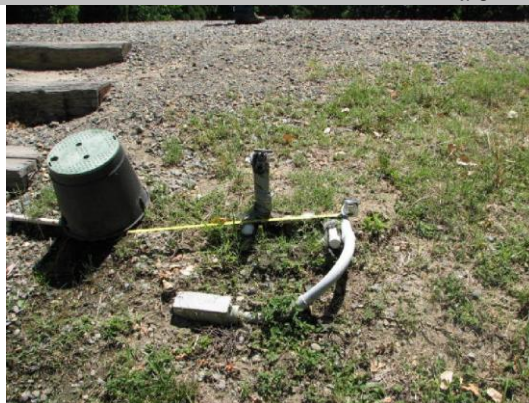
Photo 1 of 2 : UCIP\_SP\_2017\_5849\_8923.jpg

FS\_ID:5849  
DS\_ID:18902  
EP\_NO: N/A  
Repair Type: Non-Urgent  
Crossing Status: Found  
UCIP Comments: No permit identified for this crossing.  
FIELD\_STRUCT\_DESC: 1.0-inch PVC electric line through the levee, 1.5 feet below the crown. Hose-bib and electric box visible on WS shoulder. Pipe visible on downstream side of landside shoulder stairs.  
Permit No. 6293, 1969.  
FS Date: 6/19/2012 9:45:10 AM

Electrical conduit on WS slope.

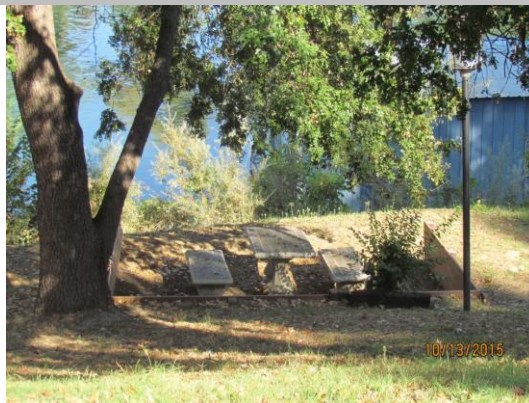
Photo 1 of 1 : SP\_2017\_MA0009\_201\_303\_20170320\_00226.jpg

LM Start	1.01	Rating **	M	Issue No.	303
LM End	1.01	Issue Type +	En	Location *	WS
Category	Earthen Levee			GPS Latitude/Longitude	
				Start	End
Item	Encroachments			38.531959 °	38.531959 °
				-121.525236 °	-121.525236 °
DWR ID	DWR_MA0009_01_f_2015_303				
Comment Code					
RW : Retaining Wall					
Inspector Comment					
The retaining wall cuts into the levee prism.

View of the table and retaining wall on the waterward side of the levee.  
Fall 2015.

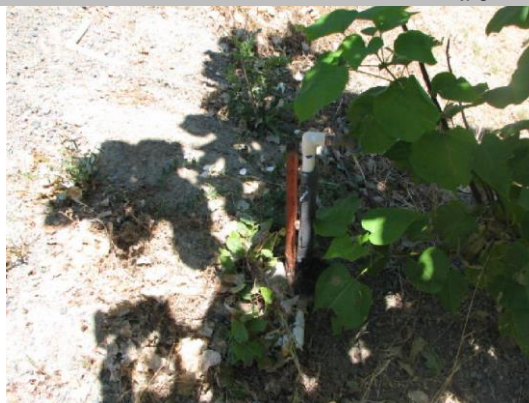
Photo 1 of 3 : UCIP\_SP\_2017\_5850\_8926.jpg

LM Start	1.02	Rating **	M	Issue No.	1782
LM End	1.02	Issue Type +	En	Location *	WS
Category	Supplemental			GPS Latitude/Longitude	
				Start	End
Item	DWR UCIP Field Study			38.531880 °	38.531880 °
				-121.525470 °	-121.525470 °
DWR ID					
Comment Code					
Inspector Comment					
FS_ID:5850 DS_ID:18904 EP_NO: N/A Repair Type: Non-Urgent Crossing Status: Found UCIP Comments: No permit identified for this crossing. FIELD_STRUCT_DESC: 1.0-inch PVC water line through the levee, 1.5 feet below the crown. Hose-bib on WS and LS shoulders. T posts mark end of line on both sides of levee. FS Date: 6/19/2012 9:47:29 AM

Hose bib and T-post on LS slope 3-feet upstream of concrete stairs.

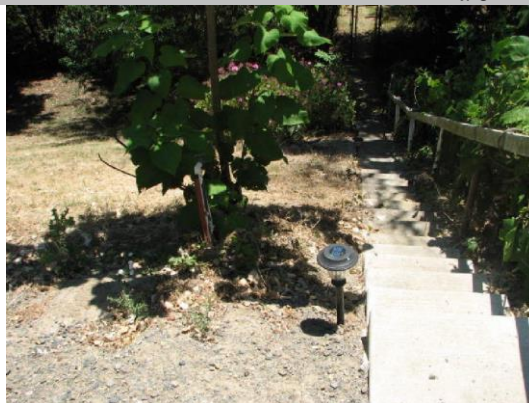
Photo 2 of 3 : UCIP\_SP\_2017\_5850\_8925.jpg

LM Start	1.02	Rating **	M	Issue No.	1782 (cont)
LM End	1.02	Issue Type +	En	Location *	WS
Category	Supplemental			GPS Latitude/Longitude	
				Start	End
Item	DWR UCIP Field Study			38.531880 °	38.531880 °
				-121.525470 °	-121.525470 °
DWR ID					
Comment Code					
Inspector Comment					
FS_ID:5850 DS_ID:18904 EP_NO: N/A Repair Type: Non-Urgent Crossing Status: Found UCIP Comments: No permit identified for this crossing. FIELD_STRUCT_DESC: 1.0-inch PVC water line through the levee, 1.5 feet below the crown. Hose-bib on WS and LS shoulders. T posts mark end of line on both sides of levee. FS Date: 6/19/2012 9:47:29 AM

Hosebib on LS slope.

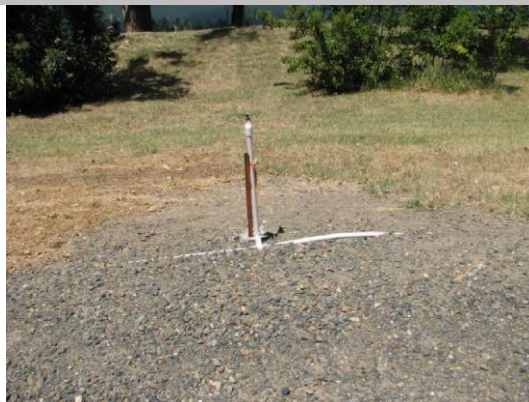
Photo 3 of 3 : UCIP\_SP\_2017\_5850\_8924.jpg

Hosebib on WS slope.

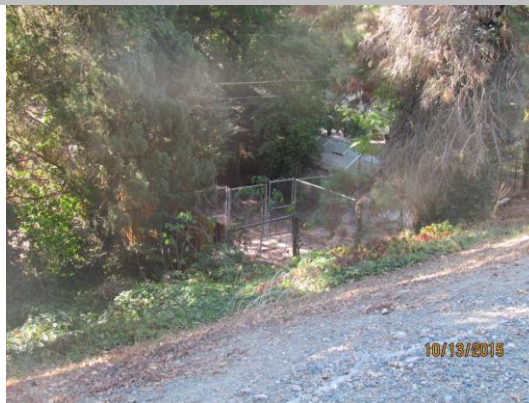
Photo 1 of 2 : SP\_2017\_MA0009\_201\_28\_20170320\_00024.jpg

LM Start	1.02	Rating **	M	Issue No.	28
LM End	1.04	Issue Type +	En	Location *	LS
Category	Earthen Levee			GPS Latitude/Longitude	
				Start	End
Item	Vegetation			38.531853 °	38.531755 °
				-121.525512 °	-121.525794 °
DWR ID	DWR_MA0009_01_s_2012_28				
Comment Code					
V6 : Landscaping					
Inspector Comment					
Permit 16352 covers wooden steps, an irrigation system, six ornamental trees and ground cover. Trees need to be trimmed.

View of the landscaping on the landward side of the levee. Fall 2015.

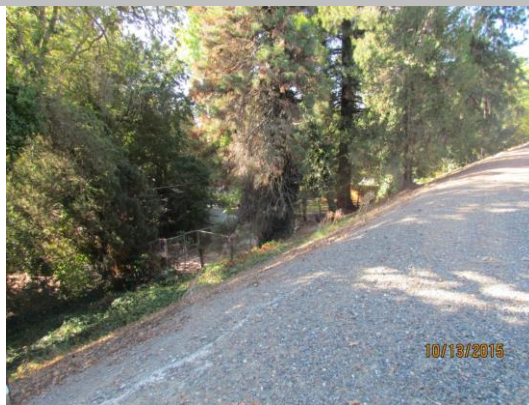
Photo 2 of 2 : SP\_2017\_MA0009\_201\_28\_20170320\_00025.jpg

Perspective view of the vegetation on the landward side of the levee looking downstream. Fall 2015.

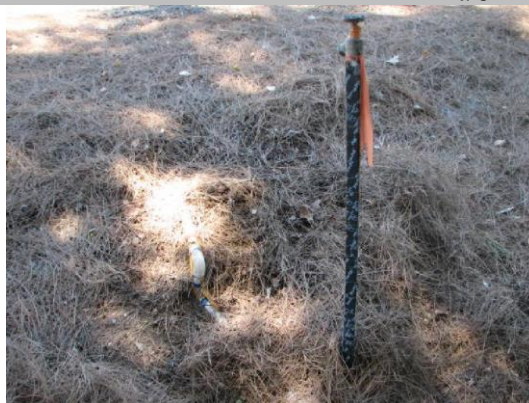
Photo 1 of 3 : UCIP\_SP\_2017\_5851\_8929.jpg

LM Start	1.04	Rating **	M	Issue No.	1783
LM End	1.04	Issue Type +	En	Location *	LS
Category	Supplemental			GPS Latitude/Longitude	
				Start	End
Item	DWR UCIP Field Study			38.531750 °	38.531750 °
				-121.525810 °	-121.525810 °
DWR ID					
Comment Code					
Inspector Comment					
FS_ID:5851 DS_ID:18905 EP_NO: N/A Repair Type: Non-Urgent Crossing Status: Found UCIP Comments: No permit identified for this crossing. Pipe open on WS slope. FIELD_STRUCT_DESC: 0.75-inch PVC water line through the levee, 1.5 feet below the crown. Hose-bib on LS shoulders. FS Date: 6/19/2012 9:50:50 AM

Hosebib on LS slope.

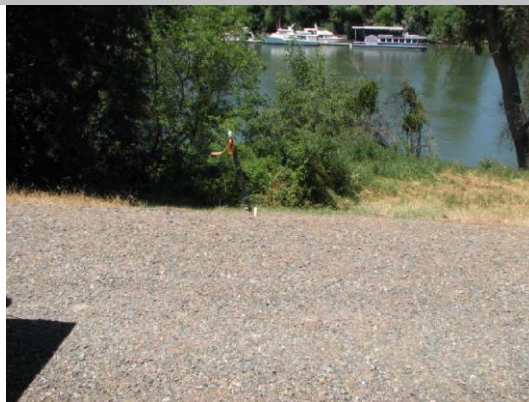
Photo 2 of 3 : UCIP\_SP\_2017\_5851\_8928.jpg

Hosebib on WS slope.

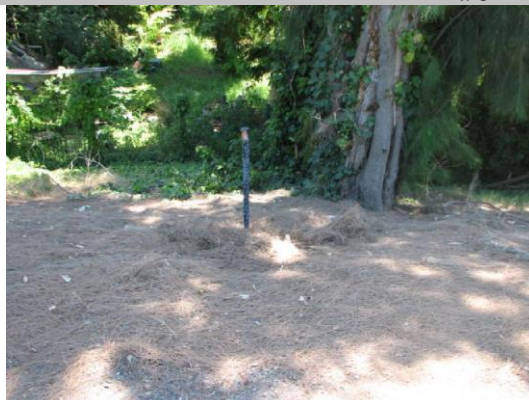
Photo 3 of 3 : UCIP\_SP\_2017\_5851\_8927.jpg

LM Start	1.04	Rating **	M	Issue No.	1783 (cont)
LM End	1.04	Issue Type +	En	Location *	LS
Category	Supplemental			GPS Latitude/Longitude	
				Start	End
Item	DWR UCIP Field Study			38.531750 °	38.531750 °
				-121.525810 °	-121.525810 °
DWR ID					
Comment Code					
Inspector Comment					
FS_ID:5851 DS_ID:18905 EP_NO: N/A Repair Type: Non-Urgent Crossing Status: Found UCIP Comments: No permit identified for this crossing. Pipe open on WS slope. FIELD_STRUCT_DESC: 0.75-inch PVC water line through the levee, 1.5 feet below the crown. Hose-bib on LS shoulders. FS Date: 6/19/2012 9:50:50 AM

Hosebib on LS slope.

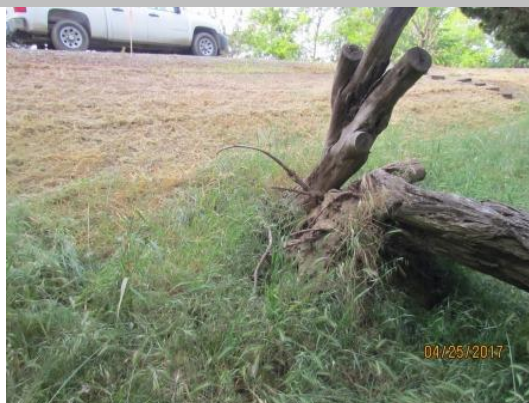
Photo 1 of 1 : SP\_2017\_MA0009\_201\_262\_20170426\_00500.jpg

LM Start	1.05	Rating **	M	Issue No.	262
LM End	1.05	Issue Type +	Ma	Location *	WS
Category	Earthen Levee			GPS Latitude/Longitude	
				Start	End
Item	Slope Stability			38.531677 °	38.531677 °
				-121.526008 °	-121.526008 °
DWR ID	DWR_MA0009_01_s_2017_262				
Comment Code					
S1 : Repair slope instability.					
Inspector Comment					
Fallen tree has exposed root system and created a void within the levee prism.

View of fallen tree on waterside slope. Spring 2017.

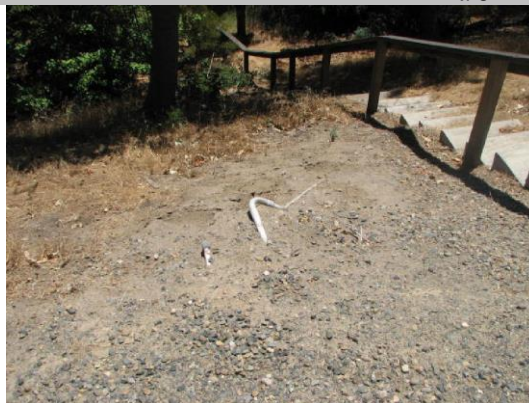
Photo 1 of 2 : UCIP\_SP\_2017\_5852\_8932.jpg

LM Start	1.06	Rating **	M	Issue No.	1784
LM End	1.06	Issue Type +	En	Location *	WS
Category	Supplemental			GPS Latitude/Longitude	
				Start	End
Item	DWR UCIP Field Study			38.531650 °	38.531650 °
				-121.526100 °	-121.526100 °
DWR ID					
Comment Code					
Inspector Comment					
FS_ID:5852 DS_ID:18906 EP_NO: N/A Repair Type: Non-Urgent Crossing Status: Found UCIP Comments: No permit identified for this crossing. FIELD_STRUCT_DESC: 0.75-inch PVC water line through the levee, 1.5 feet below the crown. Hose-bib on WS shoulder. Located 4-feet upstream of concrete stairs on LS slope. Permit No. 3580, 1961. FS Date: 6/19/2012 9:57:16 AM

Pipe on LS slope 4-feet upstream from concrete stairs.

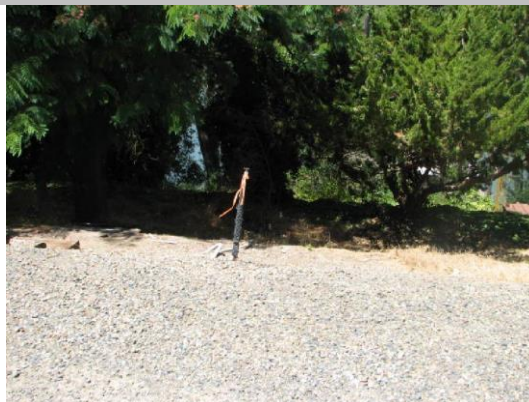
Photo 2 of 2 : UCIP\_SP\_2017\_5852\_8931.jpg

LM Start	<b>1.06</b>	Rating **	M	Issue No.	<b>1784 (cont)</b>
LM End	<b>1.06</b>	Issue Type +	En	Location *	WS

Hose bib on WS shoulder.

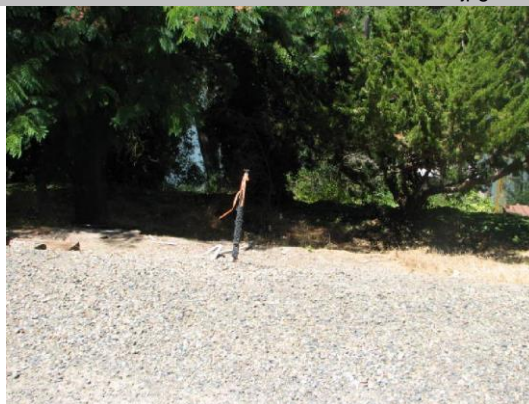
Photo 2 of 2 : UCIP\_SP\_2017\_5857\_8941.jpg

LM Start	<b>1.06</b>	Rating **	M	Issue No.	<b>1785 (cont)</b>
LM End	<b>1.06</b>	Issue Type +	En	Location *	WS

Electrical conduit on WS slope.

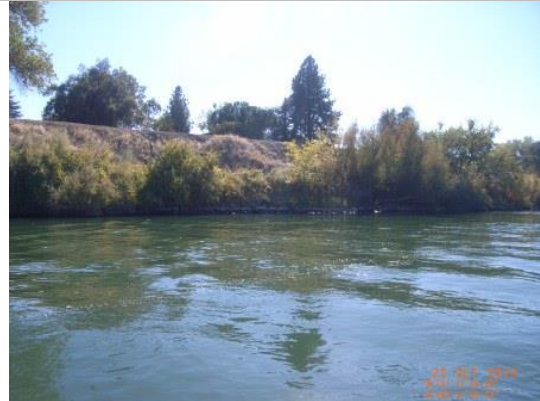
Photo 1 of 2 : SP\_2017\_MA0009\_201\_3\_20170320\_00002.jpg

LM Start	<b>1.08</b>	Rating **	M	Issue No.	<b>3 (cont)</b>
LM End	<b>1.14</b>	Issue Type +	Ma	Location *	WS

USACE 2013 Photo #1

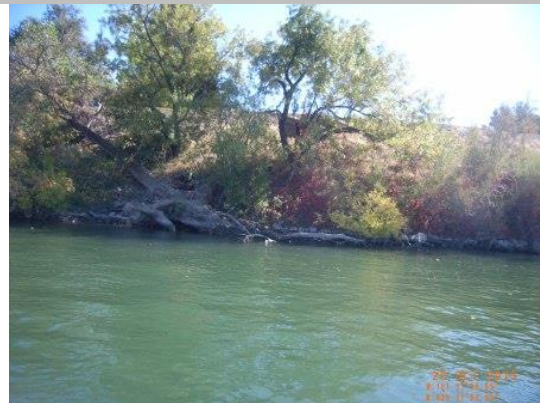
Photo 2 of 2 : SP\_2017\_MA0009\_201\_3\_20170320\_00003.jpg

USACE 2013 Photo #2

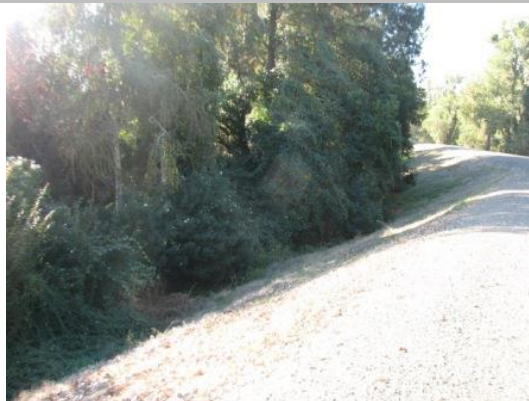
Photo 1 of 2 : SP\_2017\_MA0009\_201\_33\_20170320\_00026.jpg

LM Start	1.26	Rating **	M	Issue No.	33
LM End	1.29	Issue Type +	En	Location *	LS
Category	Earthen Levee			GPS Latitude/Longitude	
				Start	End
Item	Vegetation			38.529952 °	38.529420 °
				-121.528770 °	-121.528905 °
DWR ID	DWR_MA0009_01_s_2012_33				
Comment Code					
V6 : Landscaping					
Inspector Comment					
Fence has been permitted by Permit 16410. Trees need to be trimmed for visibility.

The trees and woody vegetation blocks visibility. Fall 2013

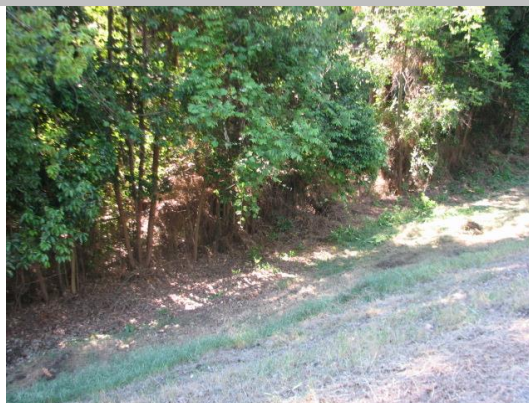
Photo 2 of 2 : SP\_2017\_MA0009\_201\_33\_20170320\_00027.jpg

LM Start	<b>1.26</b>	Rating **	M	Issue No.	<b>33 (cont)</b>
LM End	<b>1.29</b>	Issue Type +	En	Location *	LS

The owner has made great progress with the vegetation. Vegetation still blocks visibility. Spring 2014

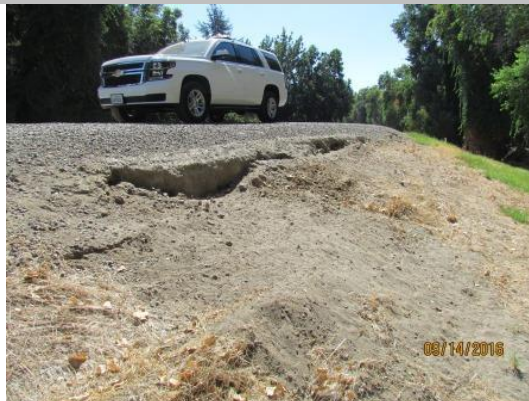
Photo 1 of 2 : SP\_2017\_MA0009\_201\_312\_20170320\_00231.jpg

LM Start	1.27	Rating **	M	Issue No.	312
LM End	1.28	Issue Type +	Ma	Location *	WS
Category	Earthen Levee			GPS Latitude/Longitude	
				Start	End
Item	Erosion / Bank Caving			38.529798 °	38.529679 °
				-121.528808 °	-121.528858 °
DWR ID	DWR_MA0009_01_f_2015_312				
Comment Code					
E2 : Schedule repair of erosion site prior to the next inspection.					
Inspector Comment					
Repair erosion on WS of the levee.

Erosion site on the waterward side of the levee. Fall 2016 inspection.

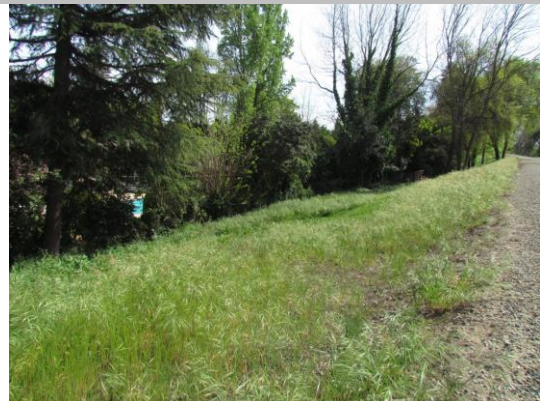
Photo 1 of 1 : SP\_2017\_MA0009\_201\_34\_20170320\_00028.jpg

LM Start	1.29	Rating **	M	Issue No.	34
LM End	1.33	Issue Type +	En	Location *	LS
Category	Earthen Levee			GPS Latitude/Longitude	
				Start	End
Item	Vegetation			38.529468 °	38.528930 °
				-121.528823 °	-121.528820 °
DWR ID	DWR_MA0009_01_s_2012_34				
Comment Code					
V6 : Landscaping					
Inspector Comment					
Fence is permitted through Permit 16354. Trees need to be thinned and trimmed for visibility.

View of vegetation on the landward side of the levee looking downstream. Spring 2015.

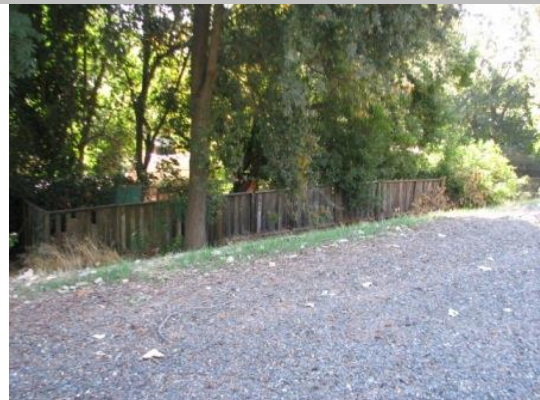
Photo 1 of 1 : SP\_2017\_MA0009\_201\_36\_20170320\_00030.jpg

LM Start	1.33	Rating **	M	Issue No.	36
LM End	1.34	Issue Type +	En	Location *	LS
Category	Earthen Levee			GPS Latitude/Longitude	
				Start	End
Item	Encroachments			38.528913 °	38.528727 °
				-121.528818 °	-121.528809 °
DWR ID	DWR_MA0009_01_s_2012_36				
Comment Code					
FE : Fence					
Inspector Comment

A wooden fence is within the easement of the levee. Fall 2013

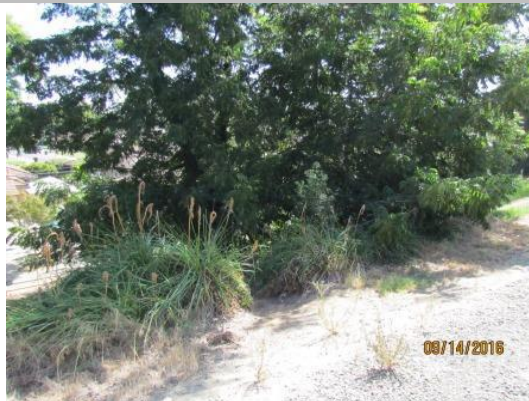
Photo 1 of 2 : SP\_2017\_MA0009\_201\_241\_20170320\_00184.jpg

LM Start	1.37	Rating **	M	Issue No.	241
LM End	1.37	Issue Type +	En	Location *	LS
Category	Earthen Levee			GPS Latitude/Longitude	
				Start	End
Item	Encroachments			38.528255 °	38.528255 °
				-121.528800 °	-121.528800 °
DWR ID	DWR_MA0009_01_f_2016_241				
Comment Code					
LI : Landscape Irrigation					
Inspector Comment					
There were vegetation around irrigation system.

Irrigation system provides water to vegetation on landside slope. Fall 2016 inspection. Another view.

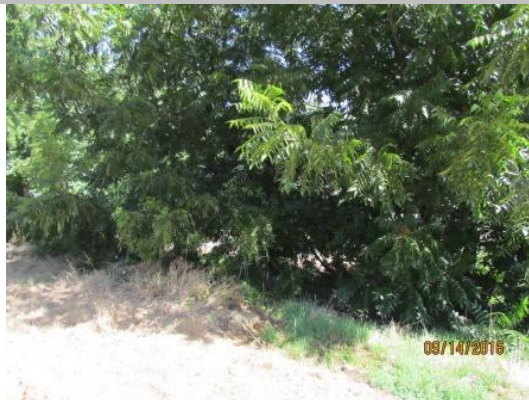
Photo 2 of 2 : SP\_2017\_MA0009\_201\_241\_20170320\_00185.jpg

LM Start	<b>1.37</b>	Rating **	M	Issue No.	<b>241 (cont)</b>
LM End	<b>1.37</b>	Issue Type +	En	Location *	LS

Irrigation system provides water to vegetation on landside slope. Fall 2016 inspection.

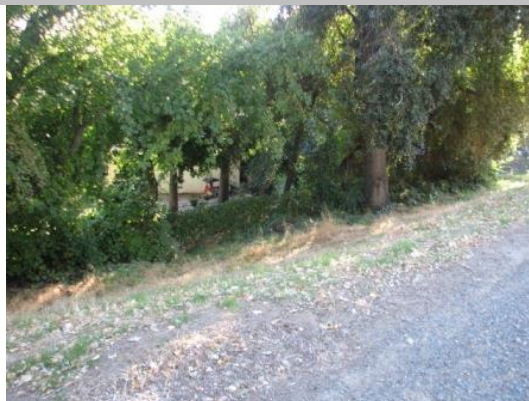
Photo 1 of 2 : SP\_2017\_MA0009\_201\_22\_20170320\_00022.jpg

LM Start	1.48	Rating **	A/W	Issue No.	22
LM End	1.48	Issue Type +	En	Location *	LS
Category	Earthen Levee			GPS Latitude/Longitude	
				Start	End
Item	Vegetation			38.526787 °	38.526787 °
				-121.528096 °	-121.528096 °
DWR ID	DWR_MA0009_01_f_2012_22				
Comment Code					
V6 : Landscaping					
Inspector Comment					
Fence is permitted by Permit 7474. Fence seems to be cleared of vegetation but vines are still present on the fence.

Vegetation grows on the fence and blocks visibility. Fall 2013

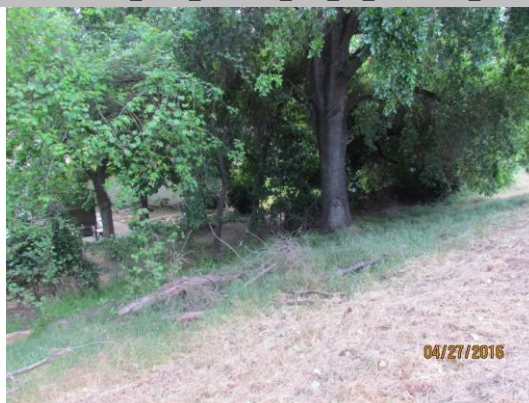
Photo 2 of 2 : SP\_2017\_MA0009\_201\_22\_20170320\_00023.jpg

LM Start	<b>1.48</b>	Rating **	A/W	Issue No.	<b>22 (cont)</b>
LM End	<b>1.48</b>	Issue Type +	En	Location *	LS

View of the fence and vegetation on the landward side of the levee looking downstream. Vegetation on the fence is gone but may grow back given time. Spring 2016.

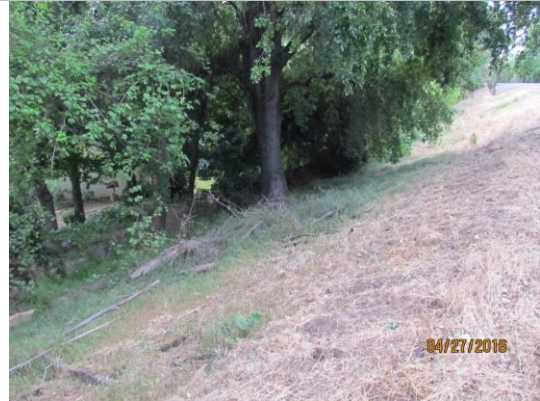
Photo 1 of 1 : SP\_2017\_MA0009\_201\_294\_20170320\_00211.jpg

LM Start	1.49	Rating **	M	Issue No.	294
LM End	1.49	Issue Type +	Ma	Location *	LS
Category	Earthen Levee			GPS Latitude/Longitude	
				Start	End
Item	Encroachments			38.526749 °	38.526749 °
				-121.528069 °	-121.528069 °
DWR ID	DWR_MA0009_01_s _ 2016_294				
Comment Code					
TR : Tree or limb					
Inspector Comment

View of the tree on the landward side of the levee looking downstream. Spring 2016.

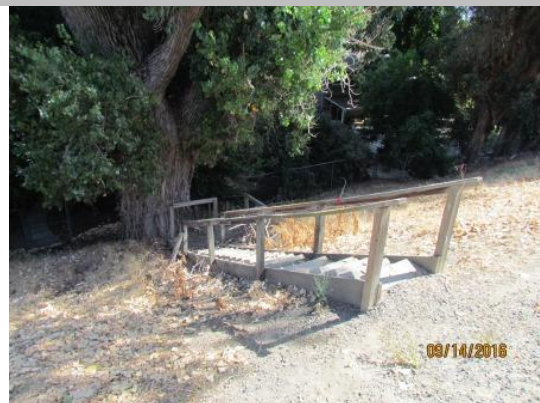
Photo 1 of 1 : SP\_2017\_MA0009\_201\_240\_20170320\_00183.jpg

LM Start	1.55	Rating **	M	Issue No.	240
LM End	1.55	Issue Type +	En	Location *	LS
Category	Earthen Levee			GPS Latitude/Longitude	
				Start	End
Item	Encroachments			38.525943 °	38.525943 °
				-121.527345 °	-121.527345 °
DWR ID	DWR_MA0009_01_f _ 2016_240				
Comment Code					
ST : Stairway					
Inspector Comment

Old wooden stairway on landside. Fall 2016 inspection.

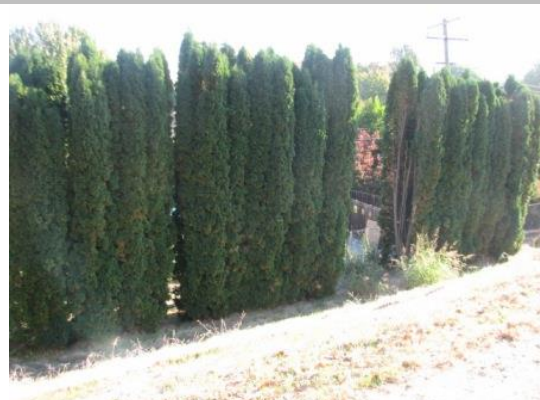
Photo 1 of 2 : SP\_2017\_MA0009\_201\_39\_20170320\_00032.jpg

LM Start	1.60	Rating **	M	Issue No.	39
LM End	1.62	Issue Type +	En	Location *	LS
Category	Earthen Levee			GPS Latitude/Longitude	
				Start	End
Item	Vegetation			38.525471 °	38.525368 °
				-121.526625 °	-121.526440 °
DWR ID	DWR_MA0009_01_s _ 2012_39				
Comment Code					
V6 : Landscaping					
Inspector Comment					
Cypress trees are blocking visibility on the landward side.

The tall hedge blocks visibility. Fall 2013

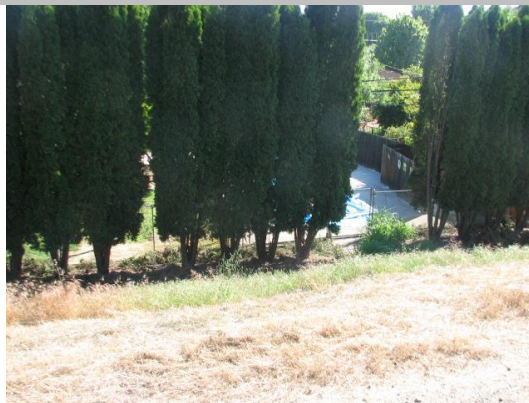
Photo 2 of 2 : SP\_2017\_MA0009\_201\_39\_20170320\_00033.jpg

LM Start	1.60	Rating **	M	Issue No.	39 (cont)	
LM End	1.62	Issue Type +	En	Location *	LS	
Category	Earthen Levee			GPS Latitude/Longitude		
				Start		End
Item	Vegetation			38.525471 °		38.525368 °
				-121.526625 °		-121.526440 °
DWR ID	DWR_MA0009_01_s_2012_39					
Comment Code						
V6 : Landscaping						
Inspector Comment						
Cypress trees are blocking visibility on the landward side.

The cypress have been raised but still partially blocks visibility. Spring 2014

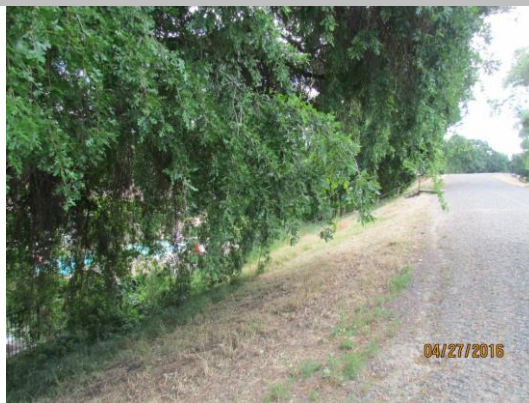
Photo 1 of 1 : SP\_2017\_MA0009\_201\_308\_20170320\_00228.jpg

LM Start	1.66	Rating **	M	Issue No.	308
LM End	1.66	Issue Type +	Ma	Location *	LS
Category	Earthen Levee			GPS Latitude/Longitude	
				Start	End
Item	Trim / Thin Trees			38.524954 °	38.524954 °
				-121.525746 °	-121.525746 °
DWR ID	DWR_MA0009_01_s_2016_308				
Comment Code					
T1 : Trim trees to at least five feet above ground level.					
Inspector Comment

View of the tree on the landward side of the levee looking downstream. Spring 2016.

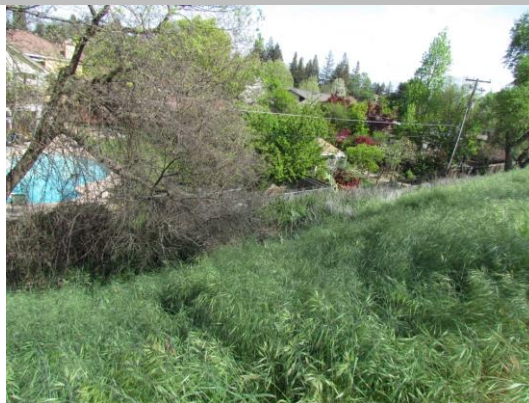
Photo 1 of 2 : SP\_2017\_MA0009\_201\_296\_20170320\_00214.jpg

LM Start	1.70	Rating **	M	Issue No.	296
LM End	1.70	Issue Type +	Ma	Location *	LS
Category	Earthen Levee			GPS Latitude/Longitude	
				Start	End
Item	Trim / Thin Trees			38.524646 °	38.524646 °
				-121.525274 °	-121.525274 °
DWR ID	DWR_MA0009_01_s_2014_296				
Comment Code					
T1 : Trim trees to at least five feet above ground level.					
Inspector Comment

View of tree on the landward side of the levee looking downstream. Spring 2015.
